**BERRYVILLE TOWN COUNCIL COMMUNITY DEVELOPMENT COMMITTEE
MEETING AGENDA
Berryville-Clarke County Government Center
101 Chalmers Court, Second Floor
Meeting Room A/B
Regular Meeting
March 25, 2019
2:00 p.m.**

Structural Evaluation of Livery Stable at 23 East Main Street, Berryville, VA *Final Submission*

Date: January 4, 2018

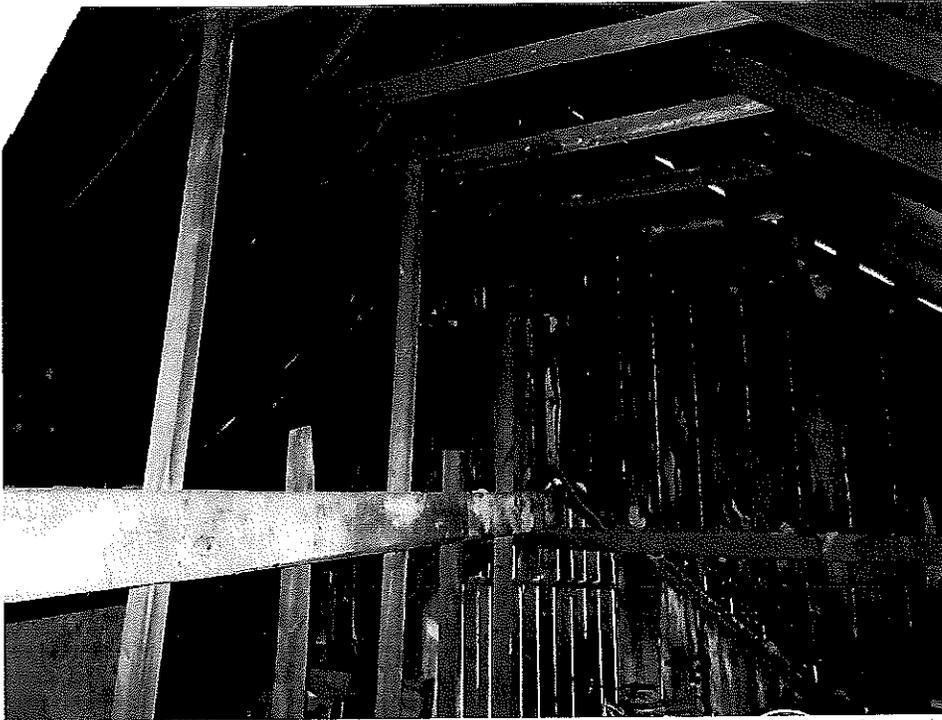
Figure 2 - Roof framing showing rafters, collar ties, and additional framing elements

Based on the visual observations, framing members making up the roof system appear to be sound and capable of withstanding snow loads applied to the system.

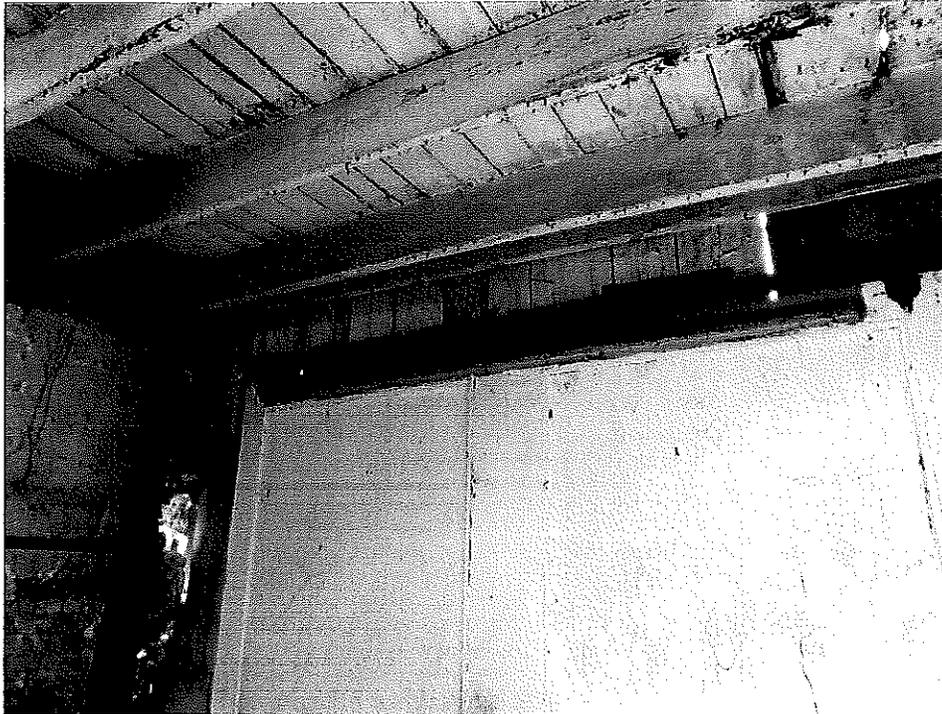
deck are six areas where the deck has been removed, which totals twenty-four square feet, each location is approximately 2-feet by 2-feet. These openings currently have light-gage metal or street signs covering each. Once a use has been determined for the space, these openings should be filled in with like decking material to form a more uniform wearing surface.

Figure 3 - View of floor framing.

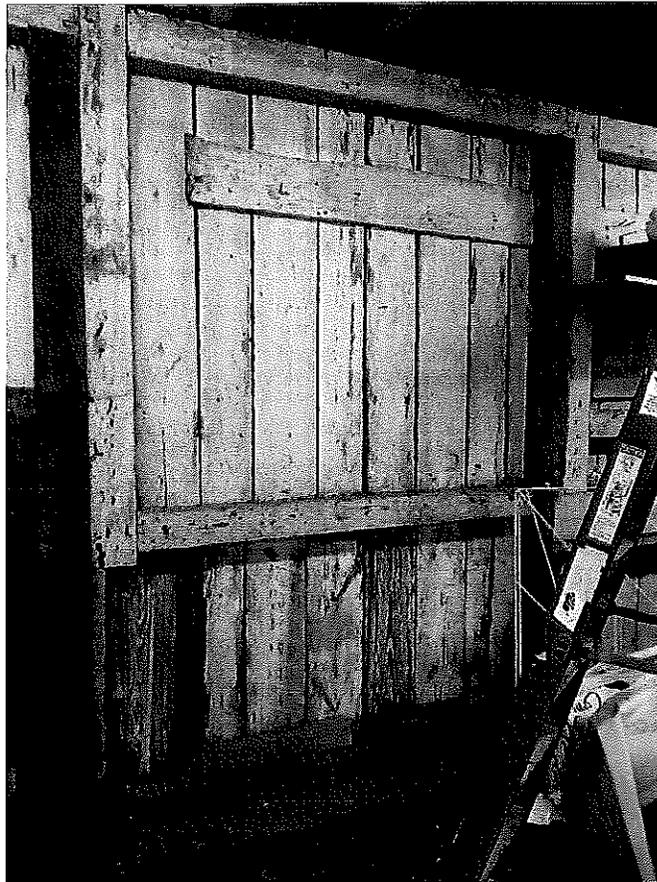
Below the floor beam, significant modifications to the wall framing has been made. It is unclear as to the reasoning behind these modifications. Each of the columns have been cut to different lengths and propped by multiple members. Between the columns below the floor beam random wall girts have been installed. These girts, and the framing supporting the columns, are fastened with wire nails, indicating work completed since the early 1900's. All of the new members' bear on a solid sawn 2-inch by 8-inch wood plate that is attached to a cast-in-place stem wall. The concrete stem wall abuts the existing building to the north and travels south to within 12 inches of the southwest corner of the building. As with the other columns along this

wall, the corner column has been cut with multiple members attached to it and carrying it to grade where it rests on stones from an original foundation wall.

Figure 5 - West wall framing example below floor.

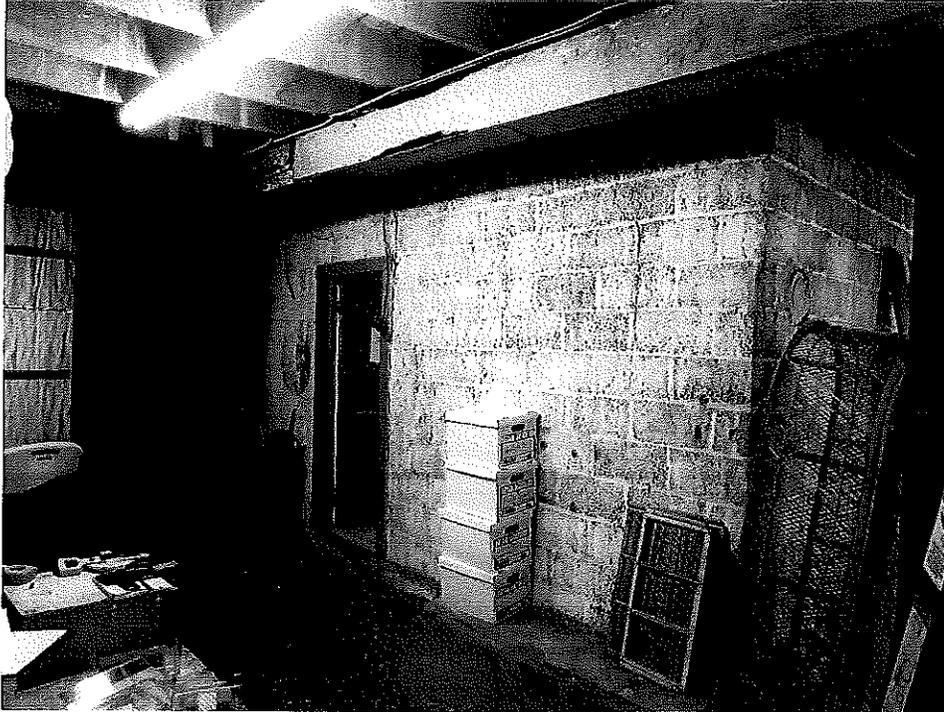
Figure 7 - Interior CMU partition, settlement cracking both sides of corner.

- a. The exterior wall of the finished area on the second floor shows evidence of animal infestation/nesting.
- b. Settlement crack visible emanating from western corner of the south concrete masonry wall.
